MRR No. 406

Research Report

Development of Photogrammetry Method in Measuring Damaged Vehicle

MALAYSIAN INSTITUTE OF ROAD SAFETY RESEARCH

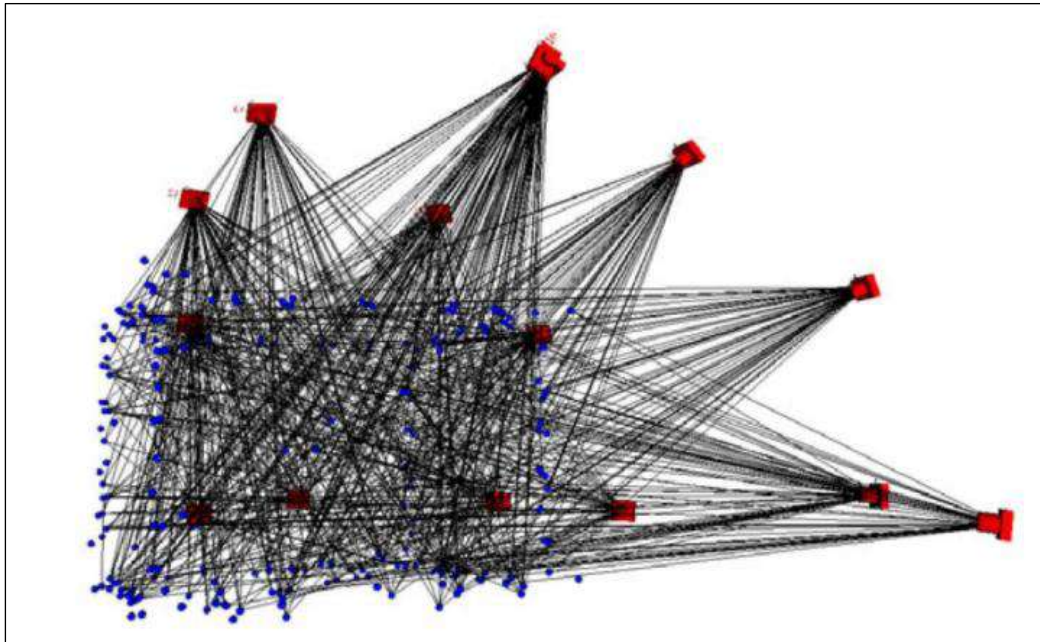
Figure 2 Bundle of rays from multiple images which form a dense network. (Source: Luhmann et al., 2013)

object point P (Luhmann et al., 2013). This technical explanation is illustrated in Figure 1. An object point can be located in 3-dimensional space through intersection of at least two (2) corresponding spatially separated image rays. Further extending concept for all image points, bundles of rays from multiple images are intersected and would form a dense network. Using the method of bundle triangulation, the intersection points associated with the 3-dimensional object point locations can be simultaneously oriented and determined (Luhmann et al., 2013).

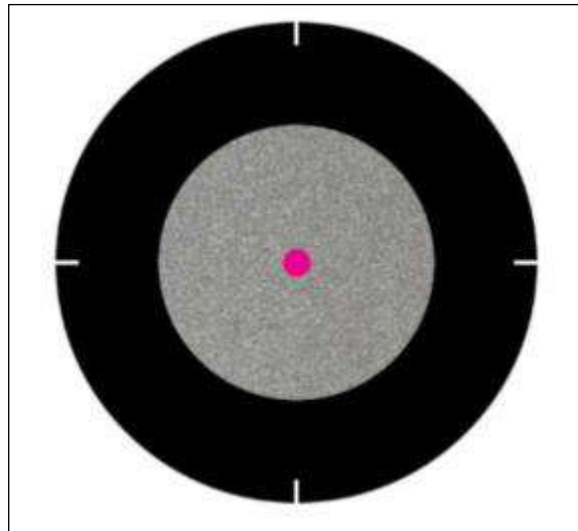
Figure 3 Targeted markers for photogrammetry

The targeted markers for photogrammetry was fabricated and used in this study. Magnetic reflective markers were used as reference points to conduct photogrammetry analysis. The reflective nature of the markers can create sufficient contrast to differentiate the markers and background. It was essential to increase the appearance of the markers to be identified as a point from any angles of view. The placement of markers was evenly distributed on the body of the damaged vehicles to ensure coordinates of every components could be obtained. Nonetheless, more markers were required on complex surface such as damaged surface in order to accurately outline the dimension of the complex surface. The reference sheet of marker placement is included in Appendix B. All the markers were placed in accordance with the reference sheet for both vehicle 1 and vehicle 2. Additional markers were placed at the frontal structure of vehicle 1 and the offside structure of vehicle 2.

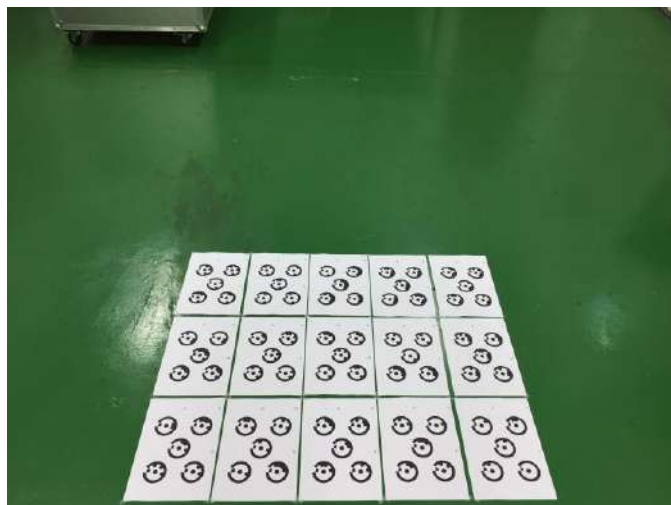
Figure 5 An example of calibration sheet for camera calibration

In photogrammetry, calibration of a camera is referred to as the process of determining the parameters of interior orientation of a camera. These parameters include principal distance, image coordinates of principal points, distortions and sensor corrections. To determine these parameters, both the cameras took 12 photos of calibration sheets from different angles and camera orientations. An example of calibration sheets is as shown in Figure 5. The interior parameters of a camera were determined using a photogrammetry software, namely Photomodeler 2018. The same software was used to conduct photogrammetry analysis to determine the 3-d coordinates of the points placed on the damaged vehicles. The reported accuracy of Photomodeler was ± 1 cm.

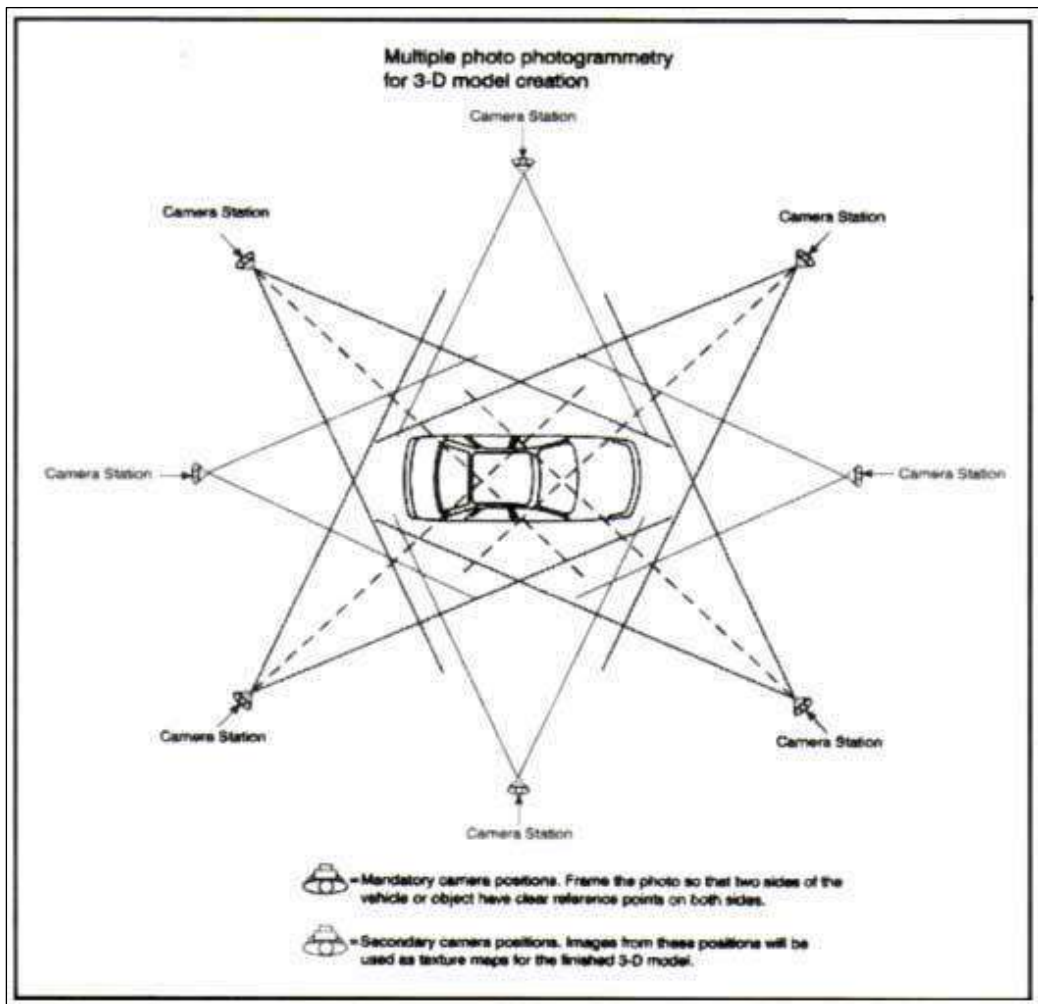
Figure 6 The basic setup for multi-photo photogrammetry

To estimate the 3-dimension coordinates of the points marked on the damaged vehicles, a minimum of eight (8) photos were required to cover all angles of view of the damaged vehicles. The basic setup of multiple photo photogrammetry is shown in Figure 3. All of these photos must be interacted with other adjacent photos to determine the position of points. To further increase the reliability and accuracy of photogrammetry, increasing the area of intersection between photo was an option. In this study, besides using the basic 8-photos setup, the photogrammetry analysis also used 10, 12 and 14 photos which enabled more area intersection between photos. The example setup for 12-photos set is illustrated in Figure 7. The outcome of the photogrammetry analysis is the 3-dimension locations of the points. The example of 3-dimension points generated by photogrammetry analysis for vehicle 2 is shown in Figure 8.

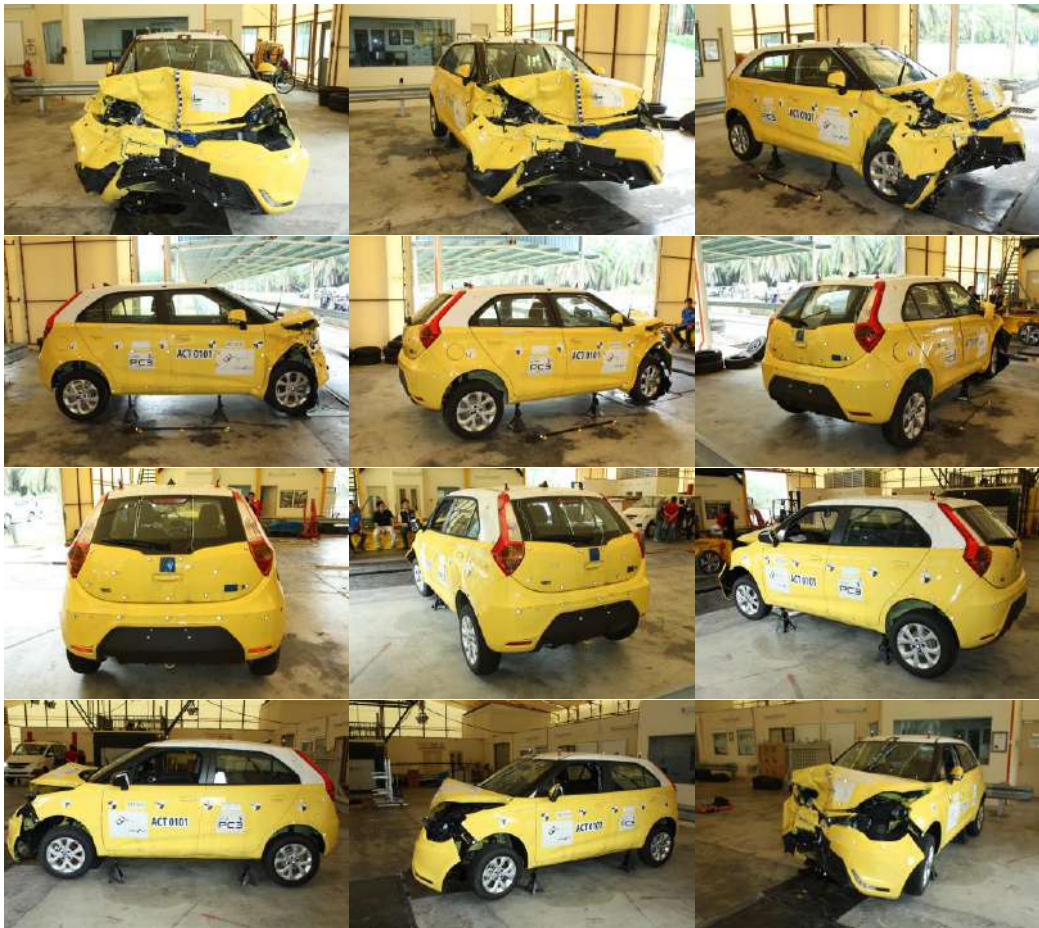
Figure 7 An example of photogrammetry setup for 12-photos set

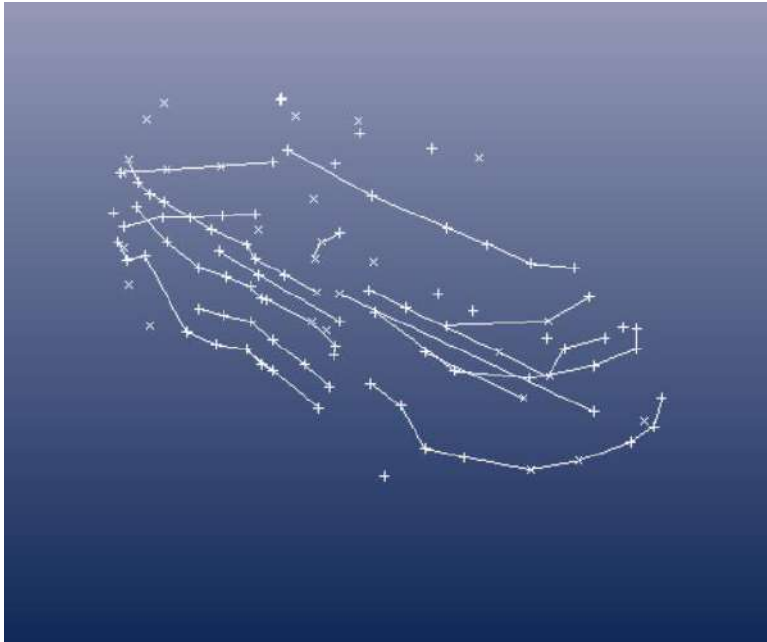
Figure 8 3-dimension points generated with photogrammetry analysis (vehicle 2)

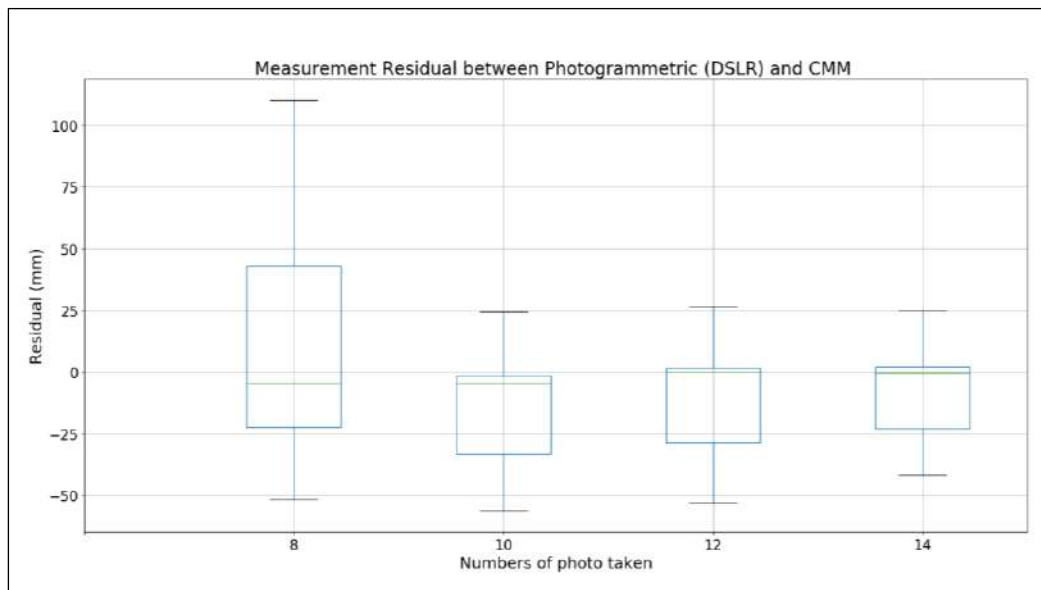
Figure 9 Boxplot of measurement residual between CMM and photogrammetry measurement with DSLR

The descriptive statistics of the residual between CMM and photogrammetry measurement for both cameras was tabulated in Table 1 and Table 2. From Table 1, it showed that the residual decreased as the number of photos used in photogrammetry increased. A reduction pattern in residual variation can also be observed in the boxplot in Figure 9, in which the size of the band and whisker of the boxplot decreased while the number of photos used increased. With 14 photos used for analysis, 75% of the points were within the residual of 22.9 mm and average residual of 7.45 mm.

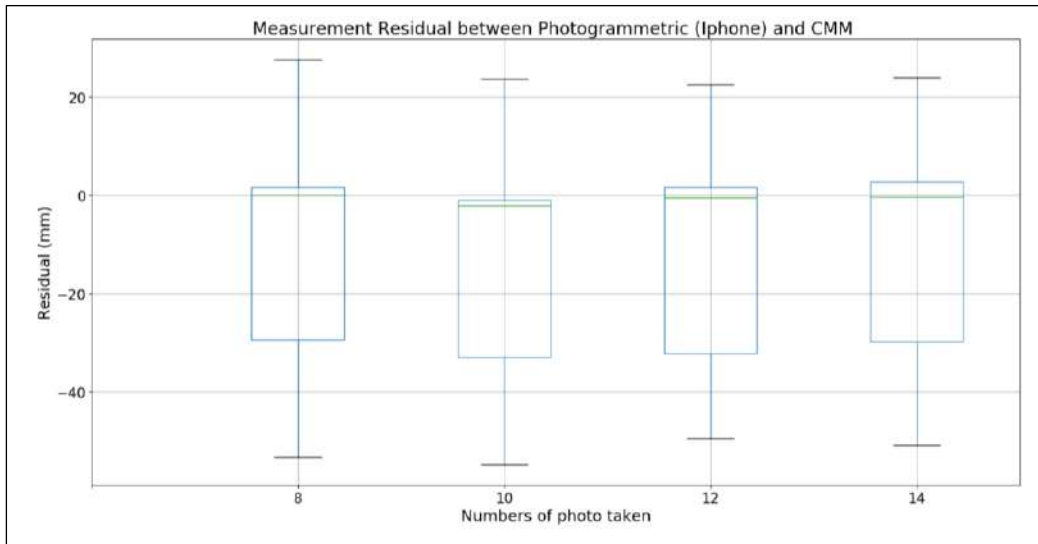
Figure 10 Boxplot of measurement residual between CMM and photogrammetry measurement with smartphone camera

A similar pattern was also observed for the iPhone 5S Plus camera. The variation of the residual also decreased as more photos were used for photogrammetry analysis. This downward pattern is shown at the boxplot in Figure 10. When the number of photos taken increased from 8 to 10, the length of the band and whiskey were reduced. Nonetheless, further increment in the number of photos did not reduce the variation in residual. In terms of accuracy, the residual for the iPhone 5S Plus camera was slightly higher compared to the Canon D500, in which 75% of the points were within the tolerance of 33 mm and average residual of 10.64 mm. The coordinates of the points generated using the photo captured by the smartphone camera were reasonably well

and the residual was slightly greater than the DSLR camera by ± 10 mm. Therefore, a slightly older smartphone camera such as iPhone 5S Plus still can produce highly accurate photogrammetry analysis.

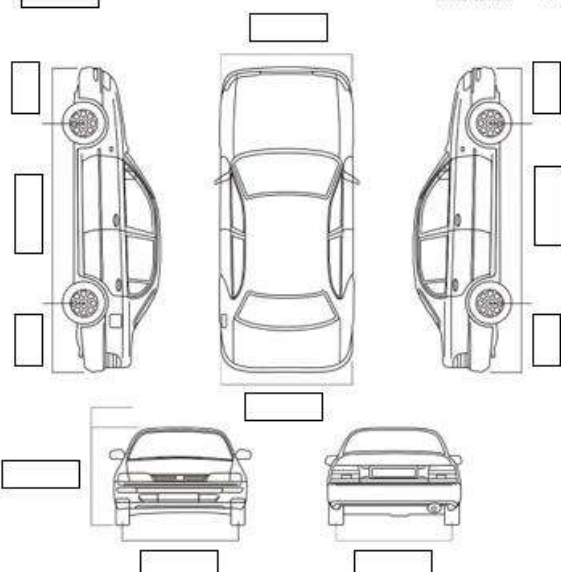
The vehicle damage measurement form used by all groups to record measured dimension using the conventional method.

The diagram shows a car with several measurement points indicated by boxes. At the top, there is a box for the roof length. On the left side, there are three boxes for the front wheel, front door, and rear door. On the right side, there are three boxes for the rear door, rear wheel, and rear door. At the bottom, there are two boxes for the front wheel and two boxes for the front door.
